1.0 Bluewater

Bluewater Site Long-Term Custody Compliance Requirements

Bluewater Site Inspection Results

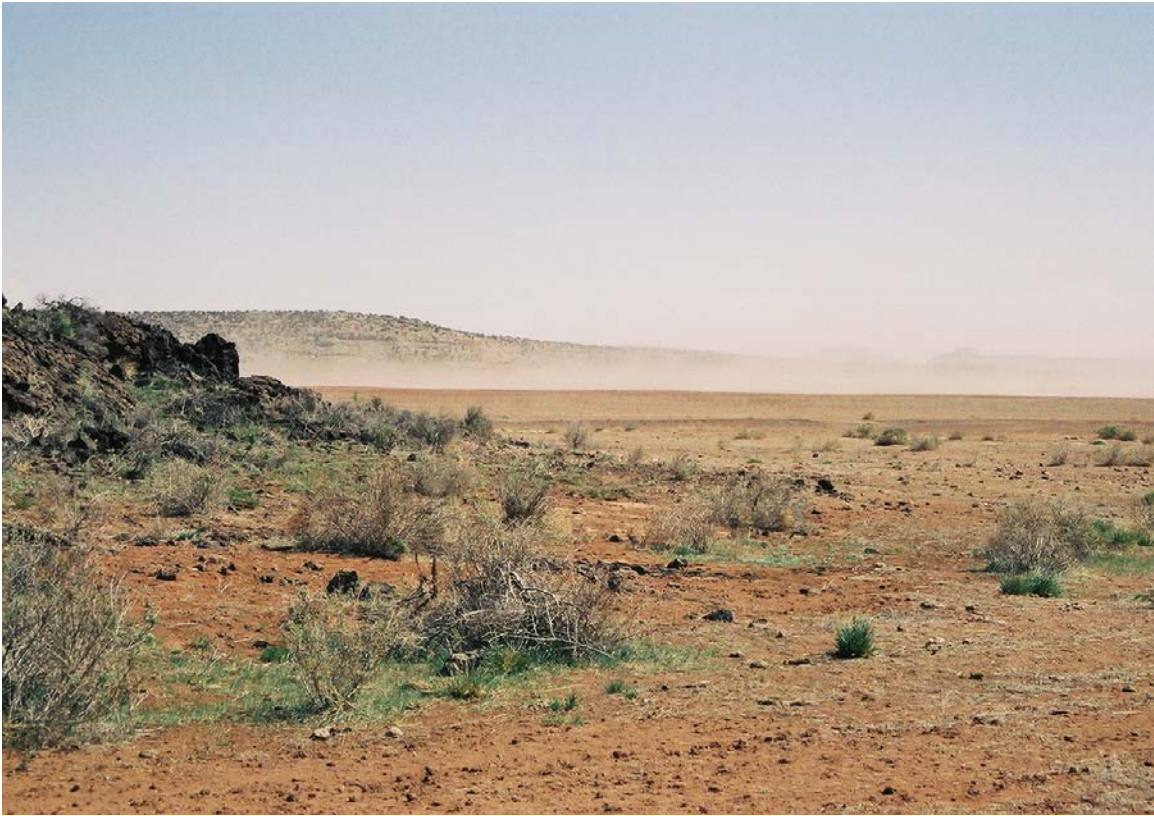
High winds occurring during the inspection were blowing a significant amount of sand and causing dust clouds (PL–1 and PL–2). Consequently the features shown in some of the photographs included in this report are less distinct than they would be under better weather conditions.

BLU 5/2003. PL-1. Blowing sand and dust, view north from north end of main tailings pile.

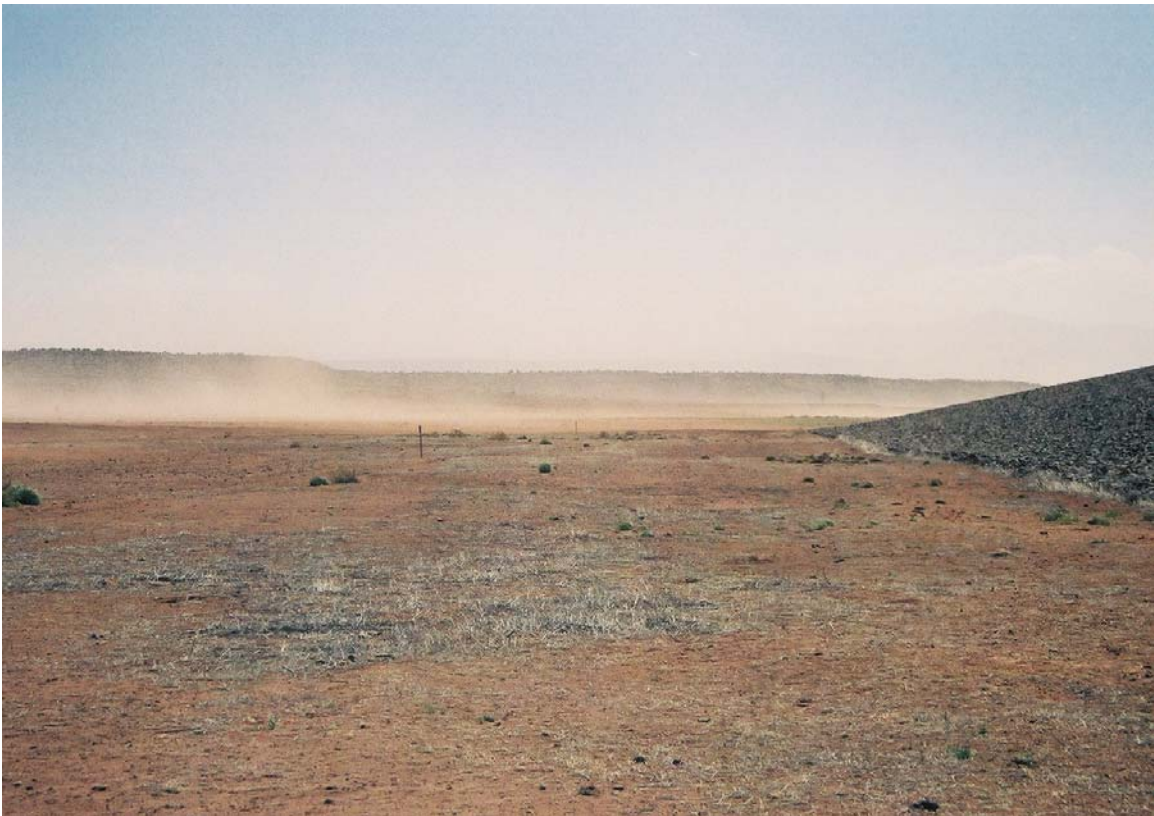
BLU 5/2003. PL-2. Blowing sand and dust, view east from north end of main tailings pile.

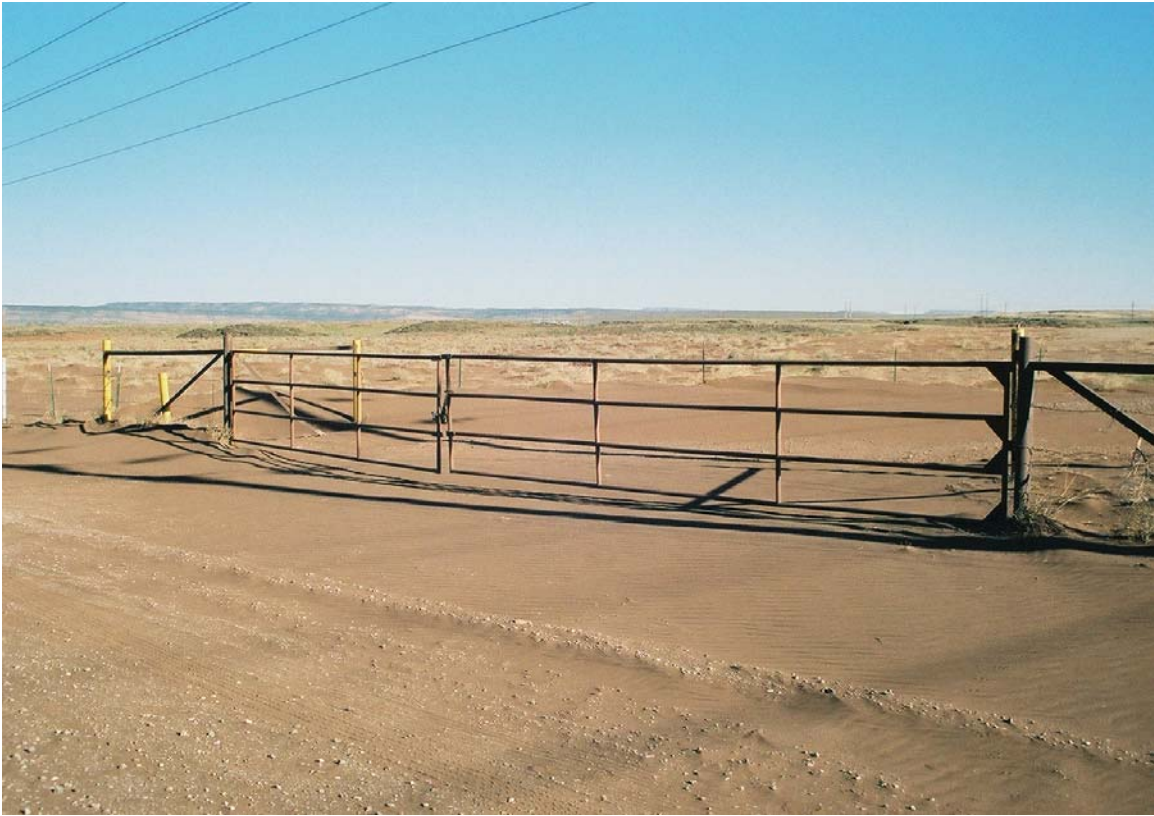
The entrance gate (at County Road 334) is a steel, double-swing stock gate. A chain and padlocks belonging to DOE and various utility companies that have rights-of-way across the site secure the gate. The access road leads from the entrance gate to the access gate. The access road is an all-weather road surfaced with crushed basalt and extends northward, along a narrow strip of DOE property, for approximately 1,700 feet to the site access gate. The access gate also is a steel, double-swing stock gate secured by padlocks keyed the same as the entrance gate. The entrance gate, access road, and access gate are in excellent condition. A significant amount of windblown sand had accumulated at the entrance gate (PL–3) and to open the gate, the inspectors had to force it through a small sand dune.

BLU 5/2003. PL-3. Entrance gate and windblown sand at County Road 334.

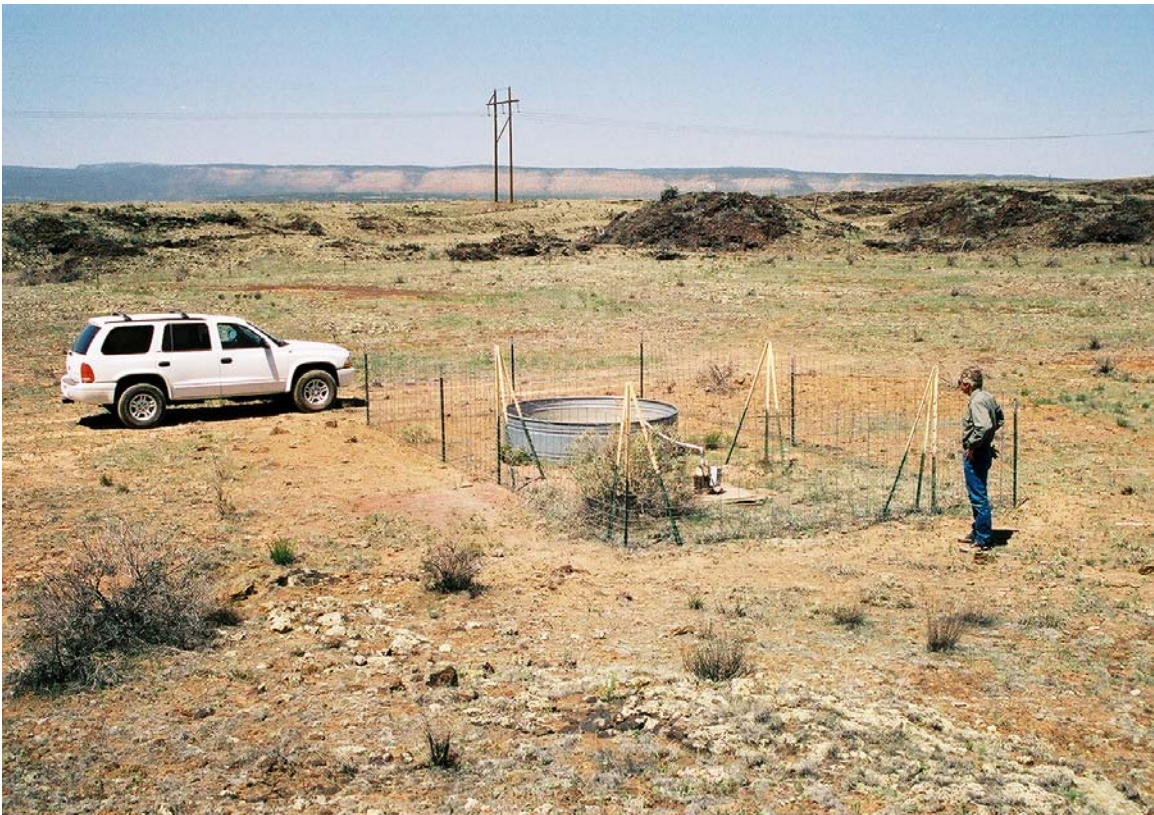
Wells previously had dedicated pumps, flow tubes, and stock tanks to contain purge water. Protective fencing placed around each well in 2001 to mitigate livestock damage was in good condition (PL-4). Tanks were missing from E(M) and Y2(M). Surface support equipment for the monitor wells (wiring and PVC pipes) is weathered and in poor condition but does not impact sampling activities.

BLU 5/2003. PL-4. Monitor well L(SG) and protective fencing.

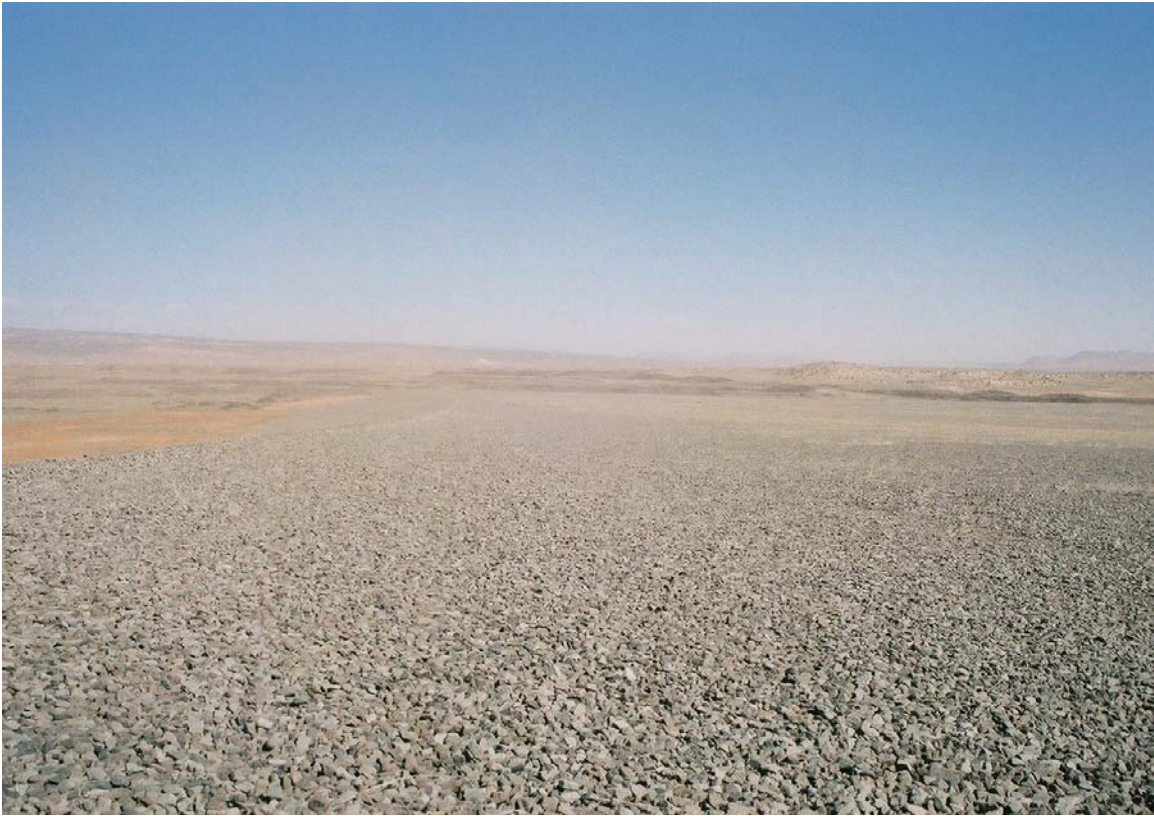
These three disposal areas are contiguous and together constitute one large disposal area of approximately 320 acres. The main tailings disposal cell is covered with basalt riprap and slopes northward (PL-5, PL-6, PL-7, and PL-8). The top slope grade decreases from approximately 3 or 4 percent at the south end to less than 0.5 percent at the north end. The top slopes of the acid tailings (PL-9) and the south bench (PL-10) disposal areas are essentially flat and covered by grass. The side slopes of all three disposal cells are protected by basalt riprap. All three disposal cells are generally in excellent condition.

BLU 5/2003. PL-5. Top of main tailings pile along southwest edge.

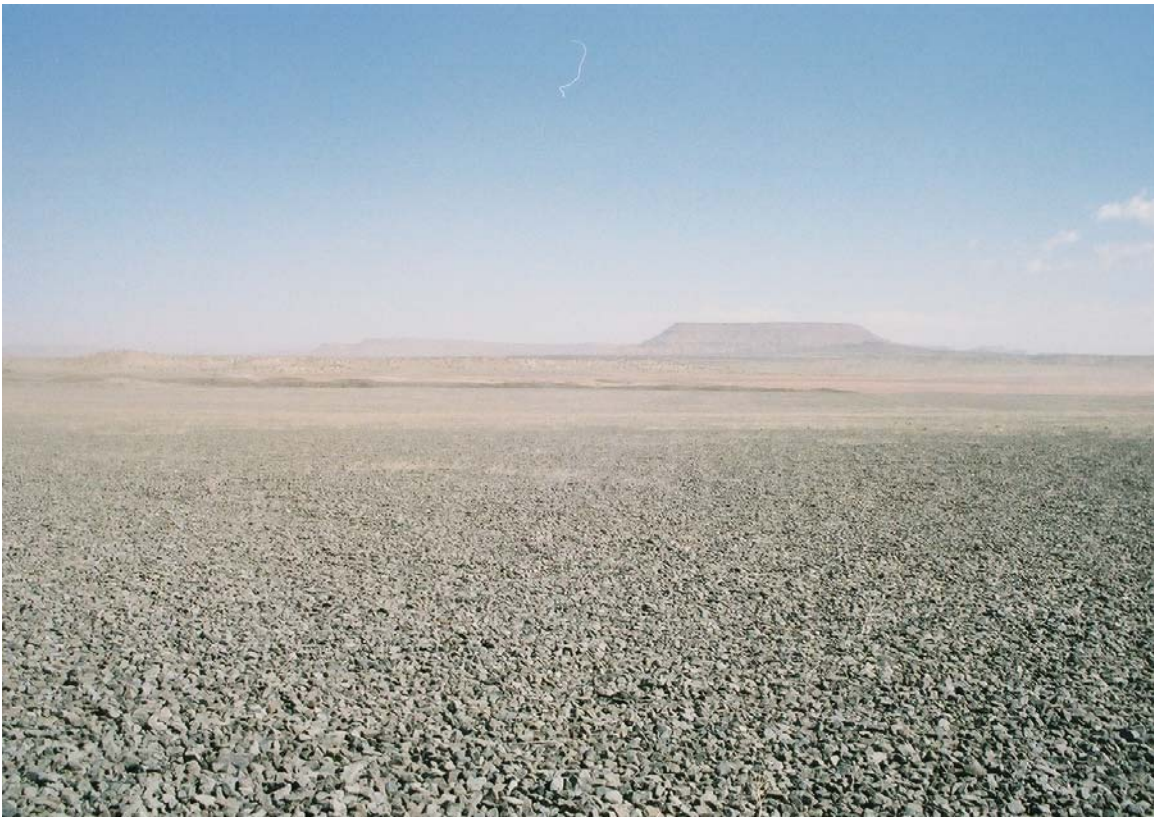
BLU 5/2003. PL-6. Top of main tailings pile, view north.

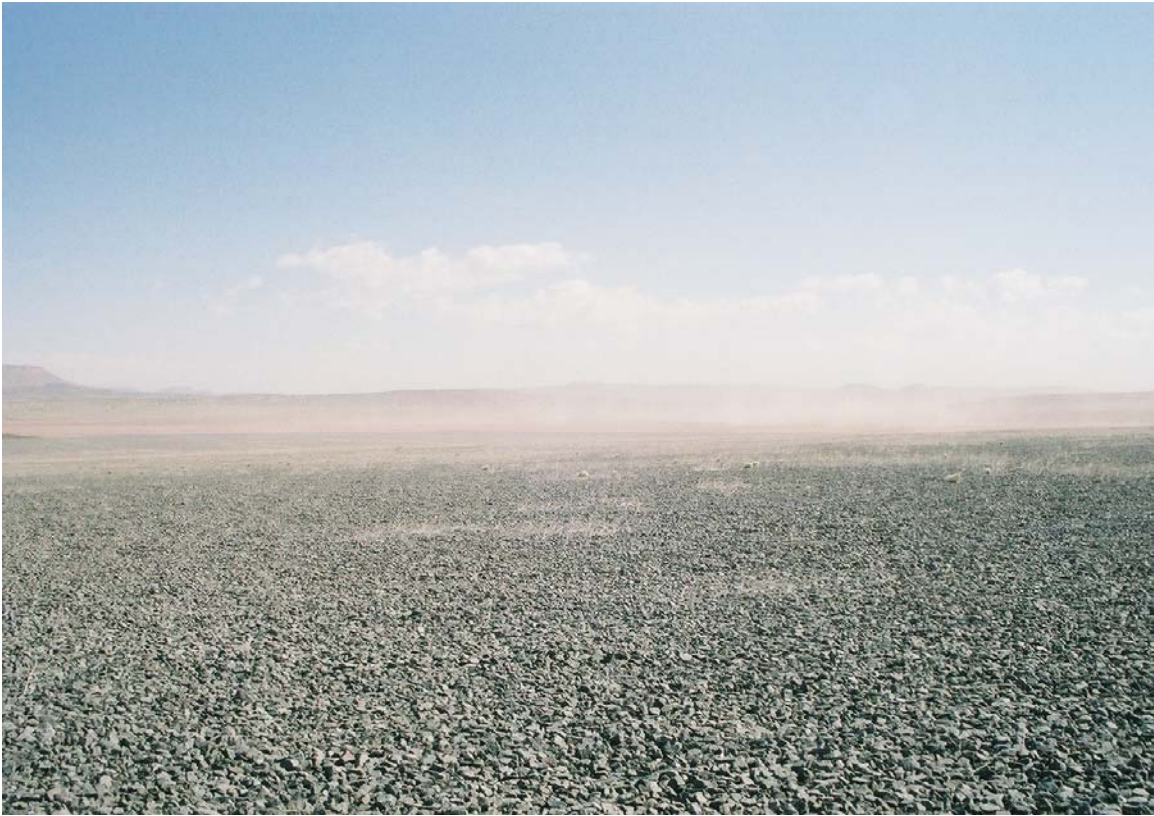
BLU 5/2003. PL-7. Top of main tailings pile, view east-northeast; blowing dust evident.

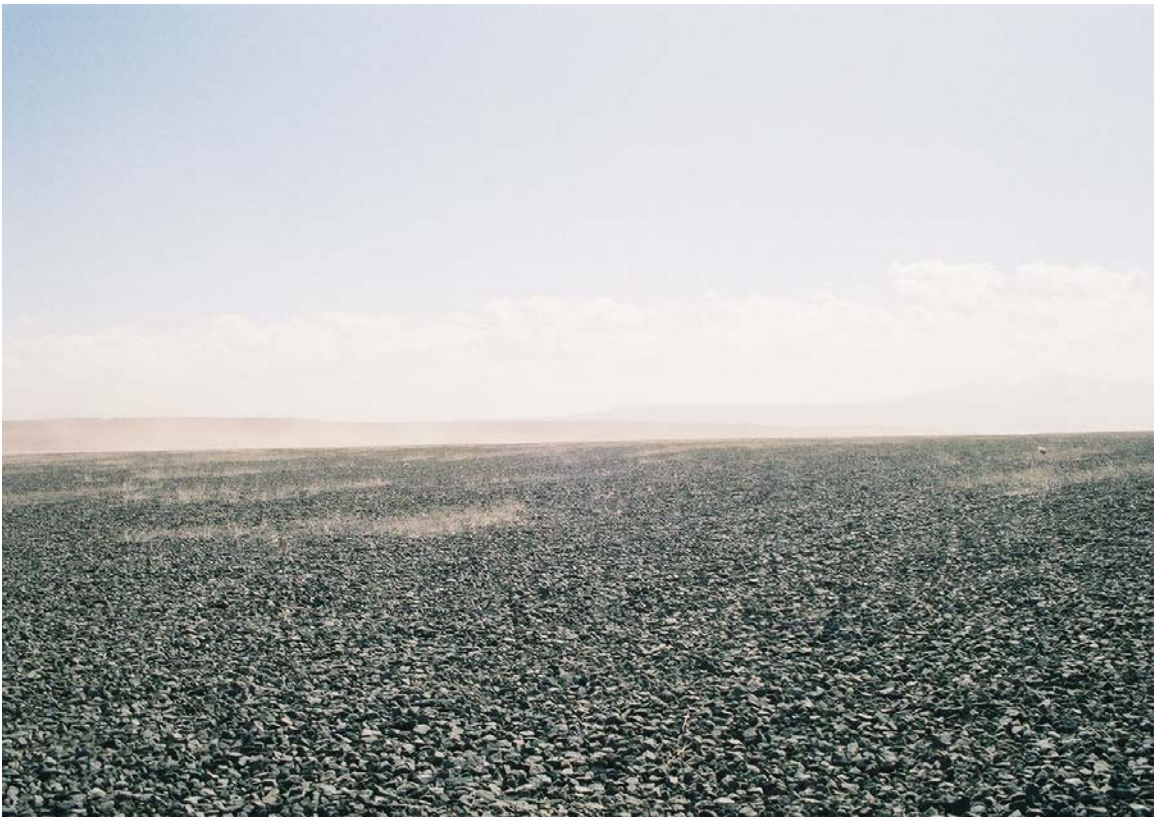
BLU 5/2003. PL-8. Top of main tailings pile, view northeast; blowing dust evident.

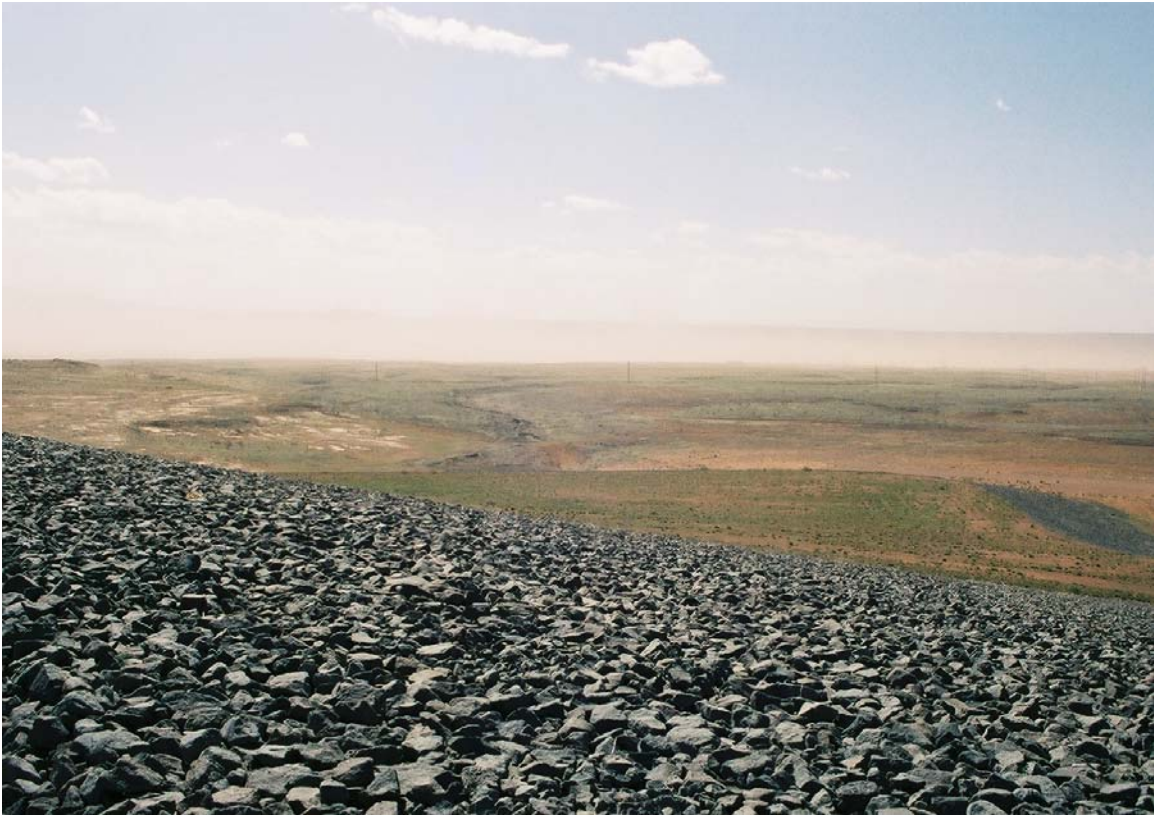
BLU 5/2003. PL-9. South bench tailings area.

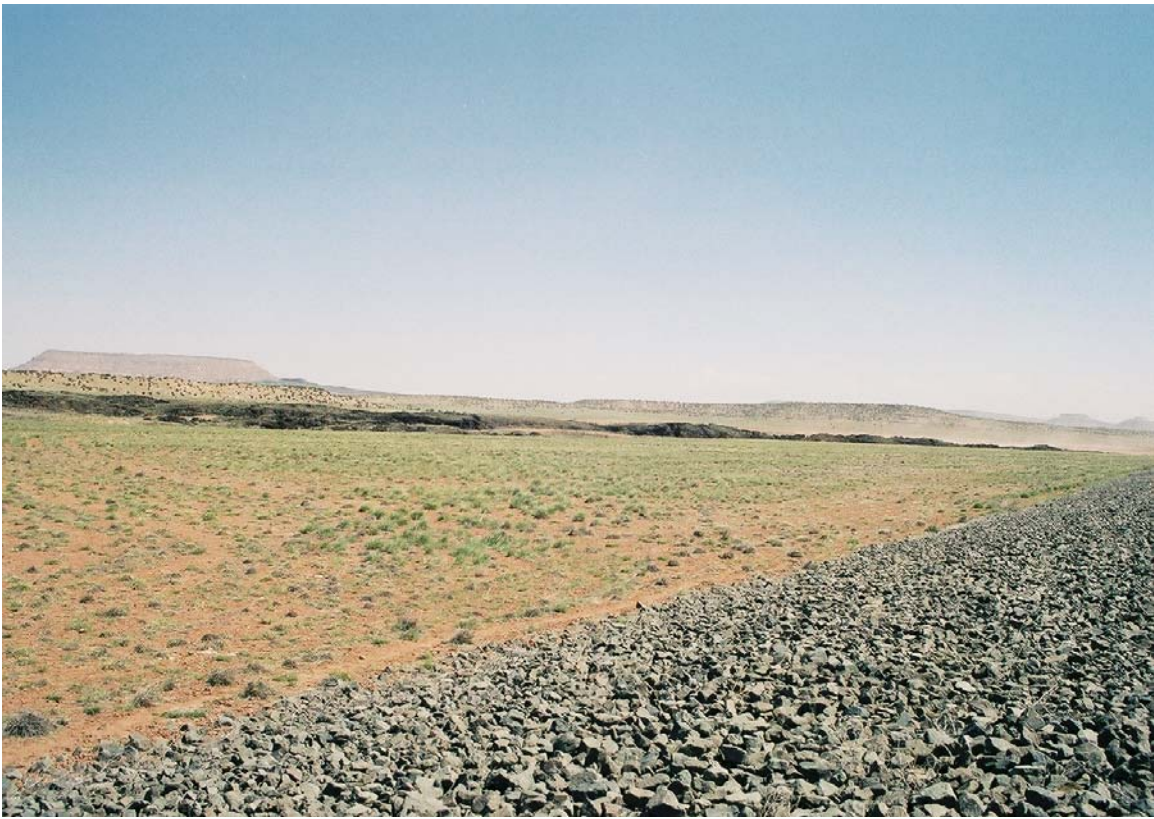
BLU 5/2003. PL-10. Cover over acid tailings.

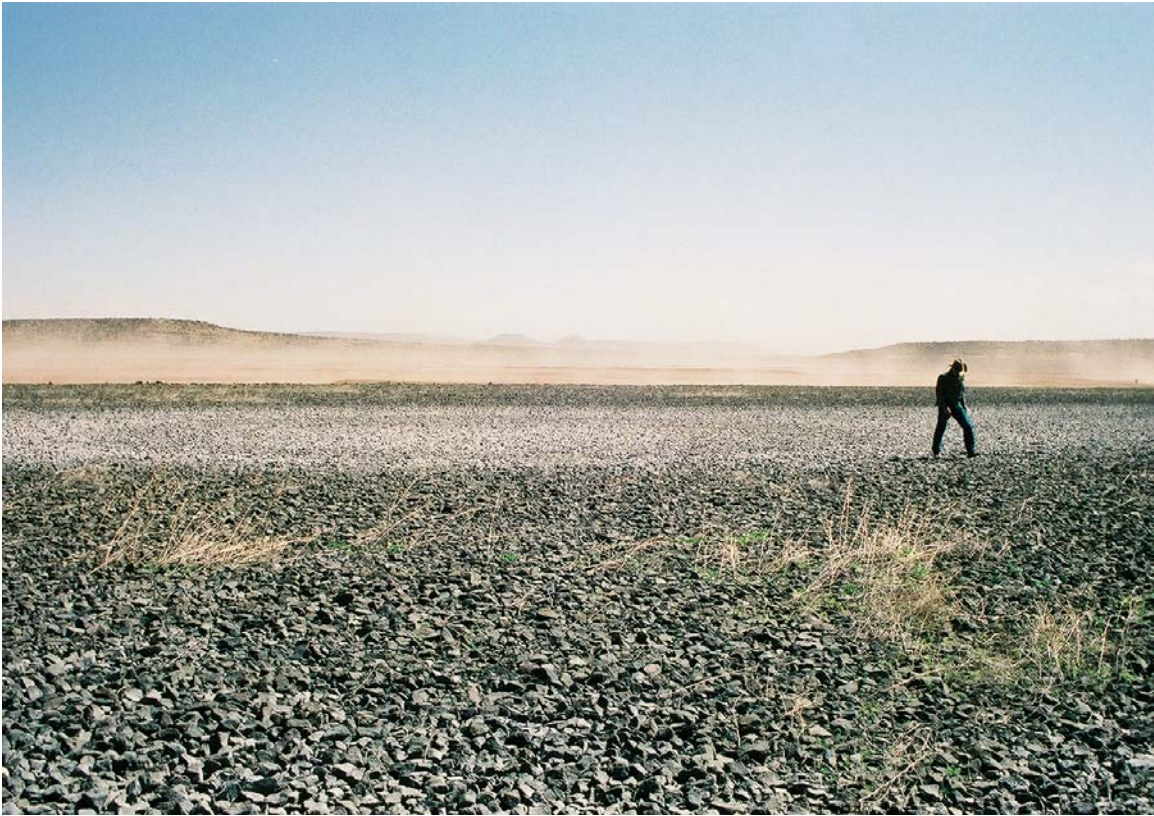
The low spots are the result of settlement or an artifact of construction. Slimes from the settling ponds were placed in the northern part of the main tailings disposal cell and areas containing slimes are more likely to settle than areas containing drier waste materials. However, a grade of less than 0.5 percent is hard to achieve over an area as large as the north end of the main tailings disposal cell. Either mechanism could account for the depressions. One small depression that was observed for the first time during this inspection has a distinctly bowl-like shape (PL-11). This depression is most likely the result of settlement.

BLU 5/2003. PL-11. Bowl shaped depression on north edge of main tailings pile.

Inspectors will continue to monitor for ponding on top of the main tailings disposal cell. Given that evaporation greatly exceeds precipitation in this area, ponding is believed to be infrequent and brief and therefore not a significant concern. Visual observations of settlement magnitude will continue.

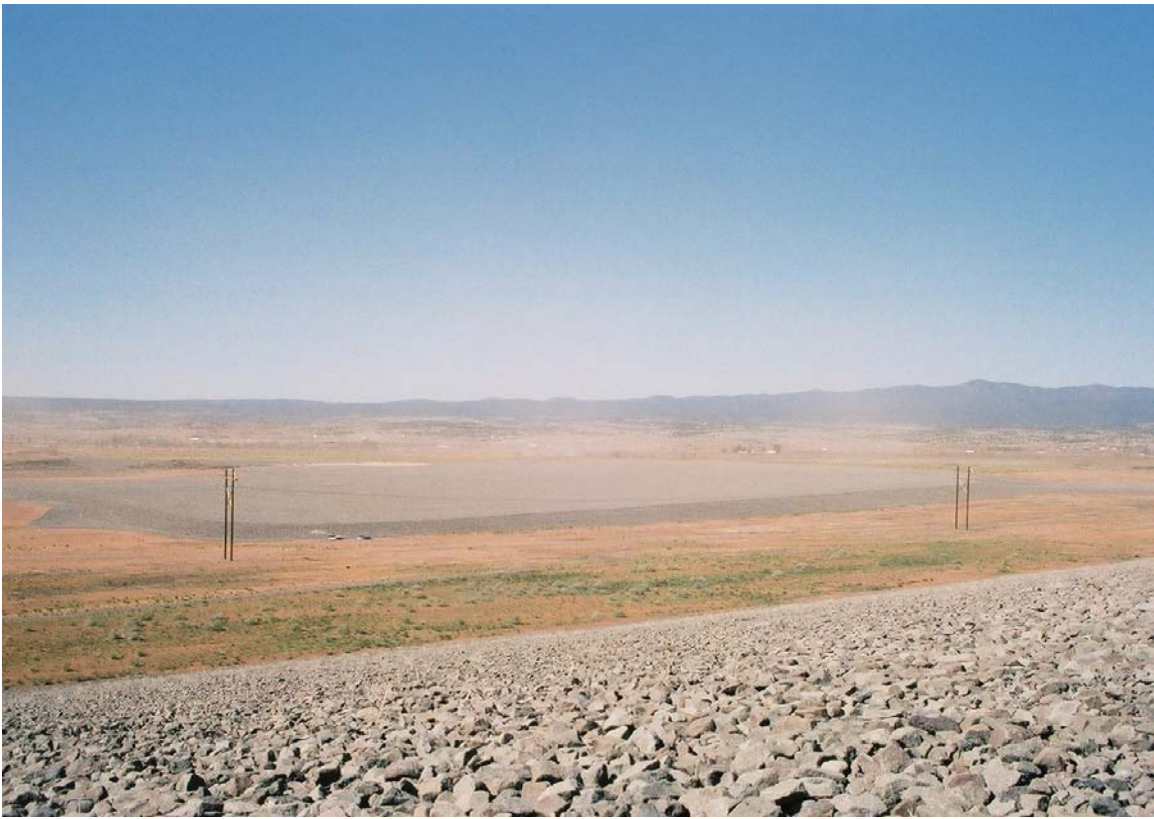
The top and side slopes of the carbonate tailings disposal cell are covered by basalt riprap (PL-12). The top, for the most part, slopes gently eastward. The small northwest and southeast extensions slope in their respective directions. The carbonate tailings disposal cell and its extensions are in excellent condition.

BLU 5/2003. PL-12. Carbonate tailings pile.

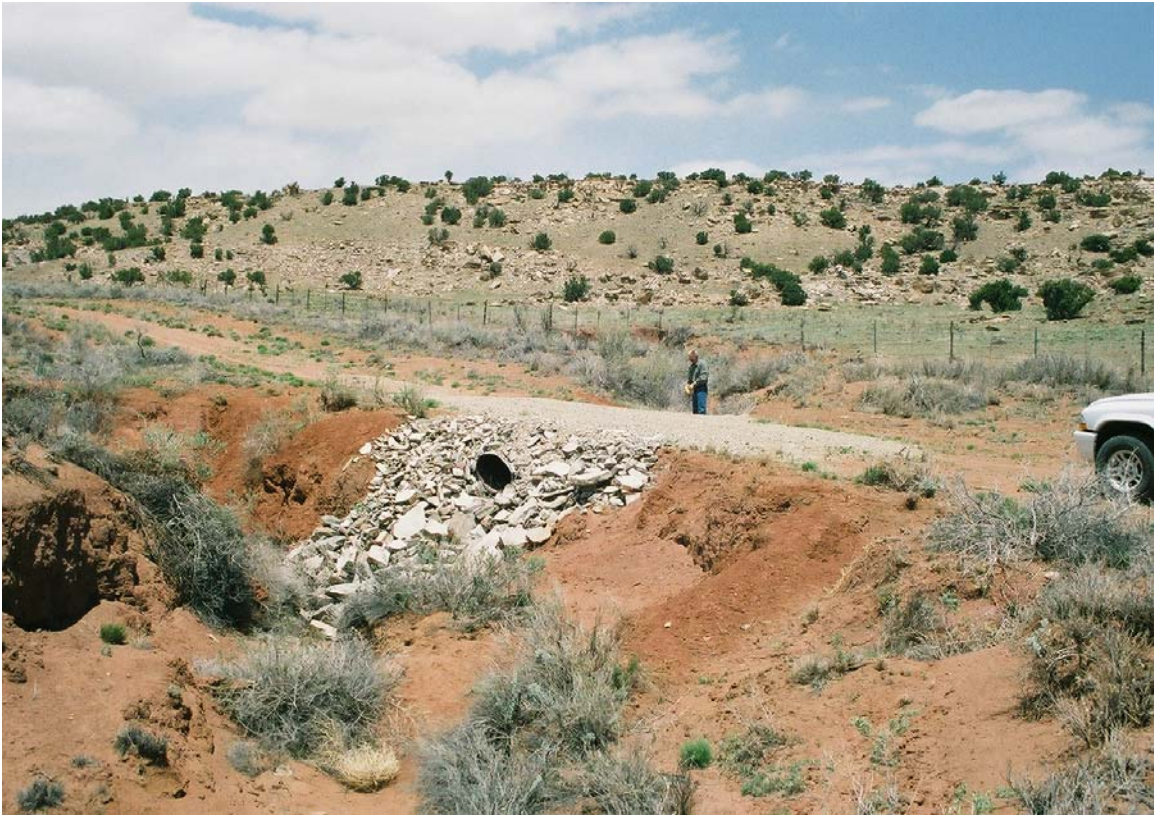
The perimeter road consists of a dirt track covered at places with crushed basalt. The road runs along the site boundary in much of the southern and most of the northern and eastern parts of the site. Most of the road is in good to excellent condition, but will require periodic maintenance. In 2001, a culvert was installed where the road was washing out south of boundary monument BM-16. The repair was inspected and remains in excellent condition (PL-13).

BLU 5/2003. PL-13. Culvert near BM-16, installed in 2001.
